# DIMENSIONS

OFFICE OF DESIGN AND CONSTRUCTION TECHNICAL BULLETIN

THIRD ANNIVERSARY ISSUE  
SPRING 1985

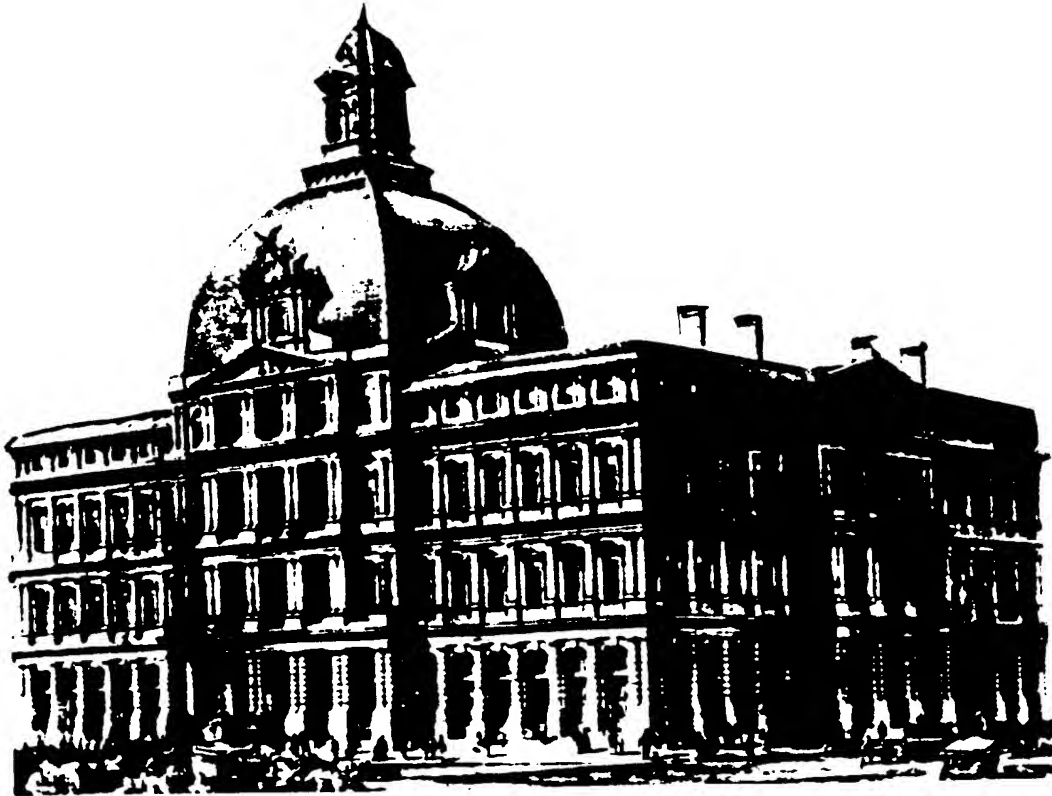
U.S. CUSTOM HOUSE AND POST OFFICE  
ST. LOUIS, MISSOURI

The site is almost entirely covered by the building, and a deep moat (8 feet wide and 29 feet deep) surrounds the building. It is a four-storied granite building with a slate-covered, steep-sided mansard dome springing from a rectangular base atop the projecting central pavilion of the south facade. The dome, lacking an ornamental belvedere and elaborate cupola which were removed in 1925, now reaches a height of 125 feet. The eminent American sculptor, Daniel Chester French (1850-1931), had as his first major commission the sculpture group "Peace and Vigilance"--two semi-reclining female figures and a spread-winged eagle carved in marble--which is located at the base of the dome. French, the son of the Assistant Secretary of the Treasury, received the commission in 1876, and the sculpture was completed in 1882.

A central cortile (approximately 75 feet square) was originally sheltered by a skylight at the main roof level. It was eventually replaced by one at the second floor level. The recent rehabilitation replaced that skylight with a new one back at the main roof level.

In addition to the four stories, the building has an attic, a basement, and a subbasement. The building, approximately 180 feet by 235 feet, is surrounded by a deep 29-foot areaway. There is a tunnel along Eighth Street, flanking the east side of the building which, when it was built (1873), served for direct mail delivery and shipment, but now is used only by freight trains bypassing the building on their way to and from Eads Bridge.
